STRUCTURAL MONITORING PROJECT

A report to British Coal Opencast on the Effects of
Opencast Blasting Operations on Residential Structures

Blasting Research Group

September 1993

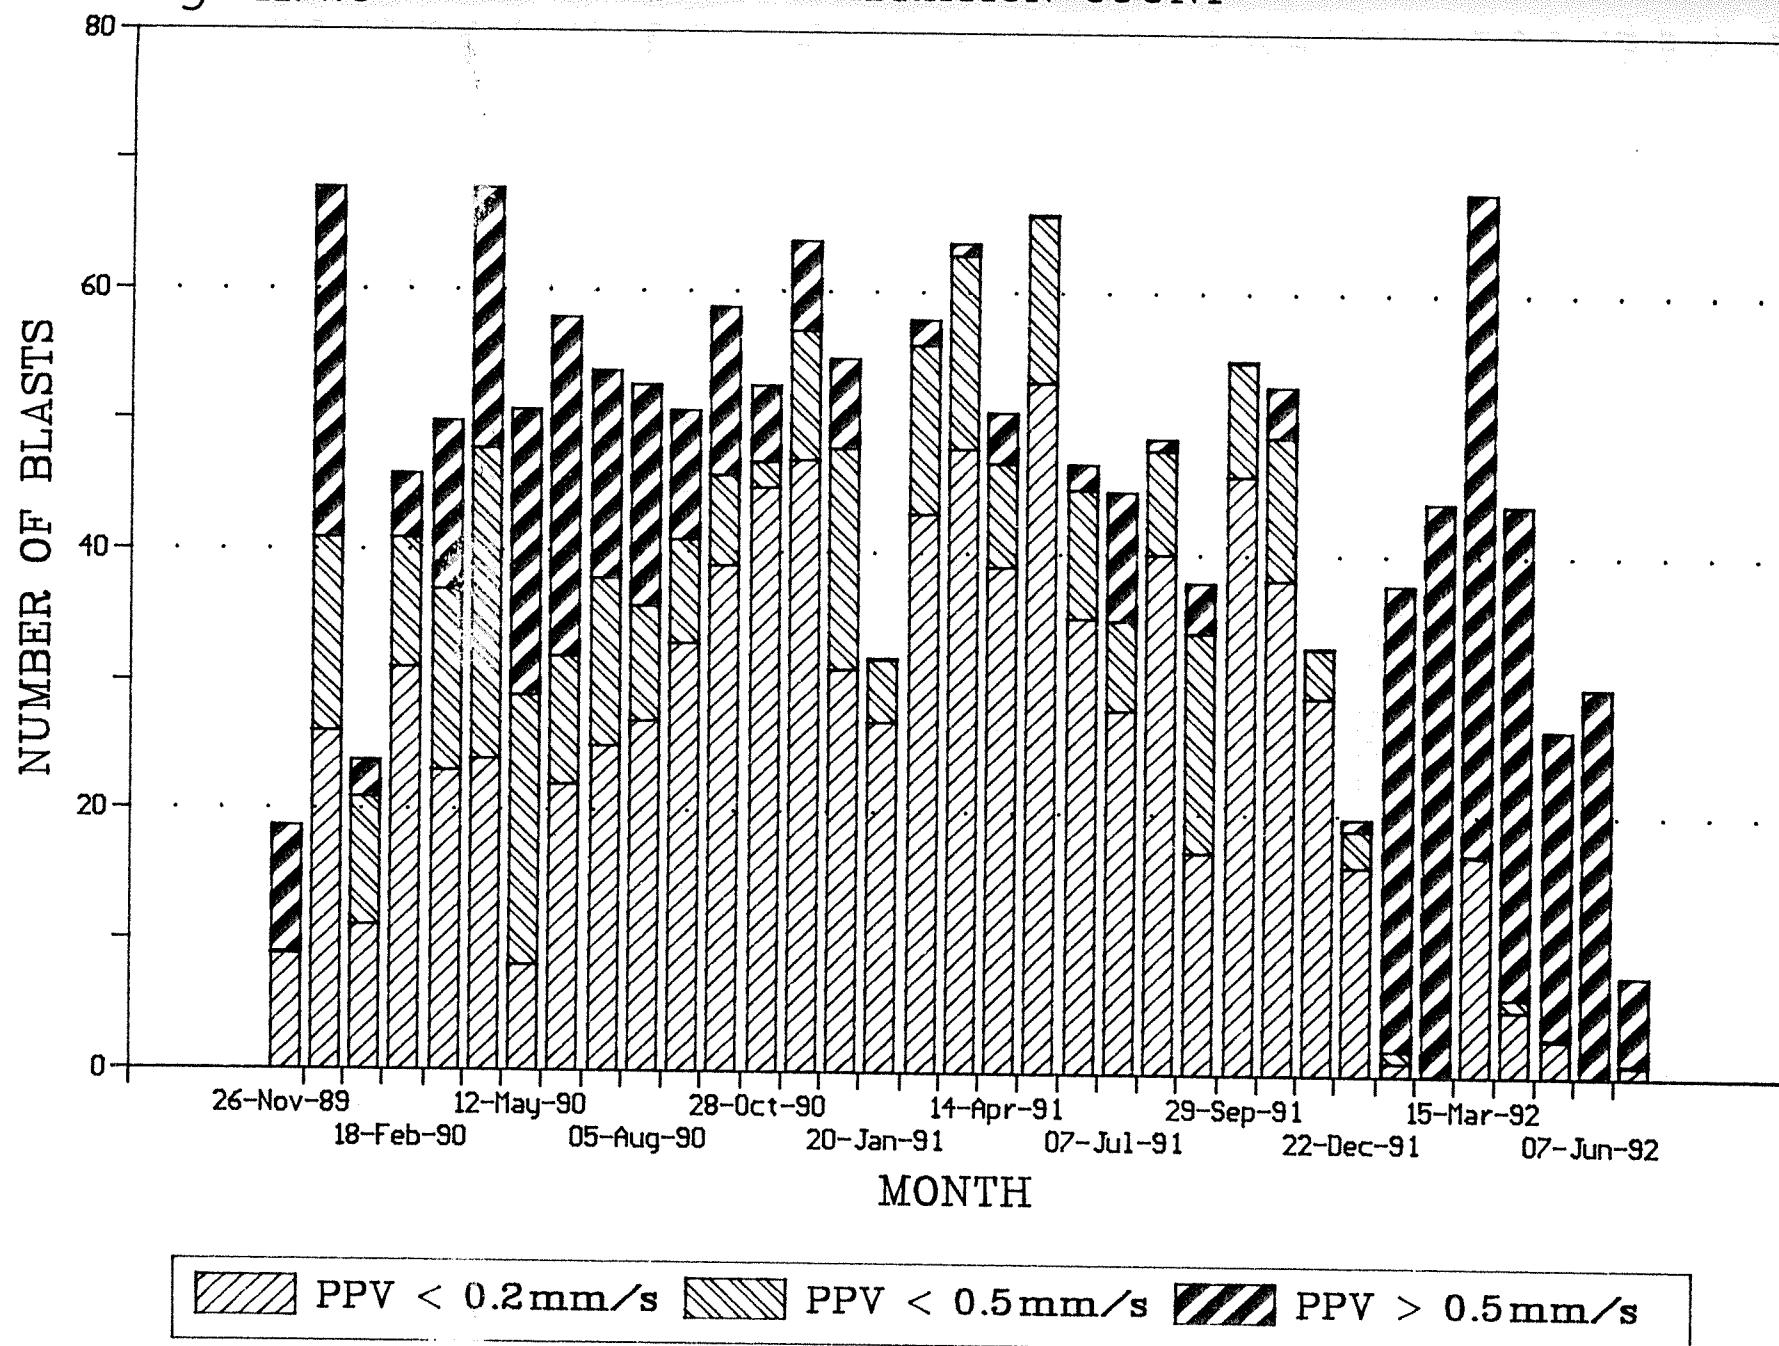
Fig. II.4.3

BLAST VIBRATION COUNT

blasts close to the property and most PPVs in excess of 0.5mm/s.

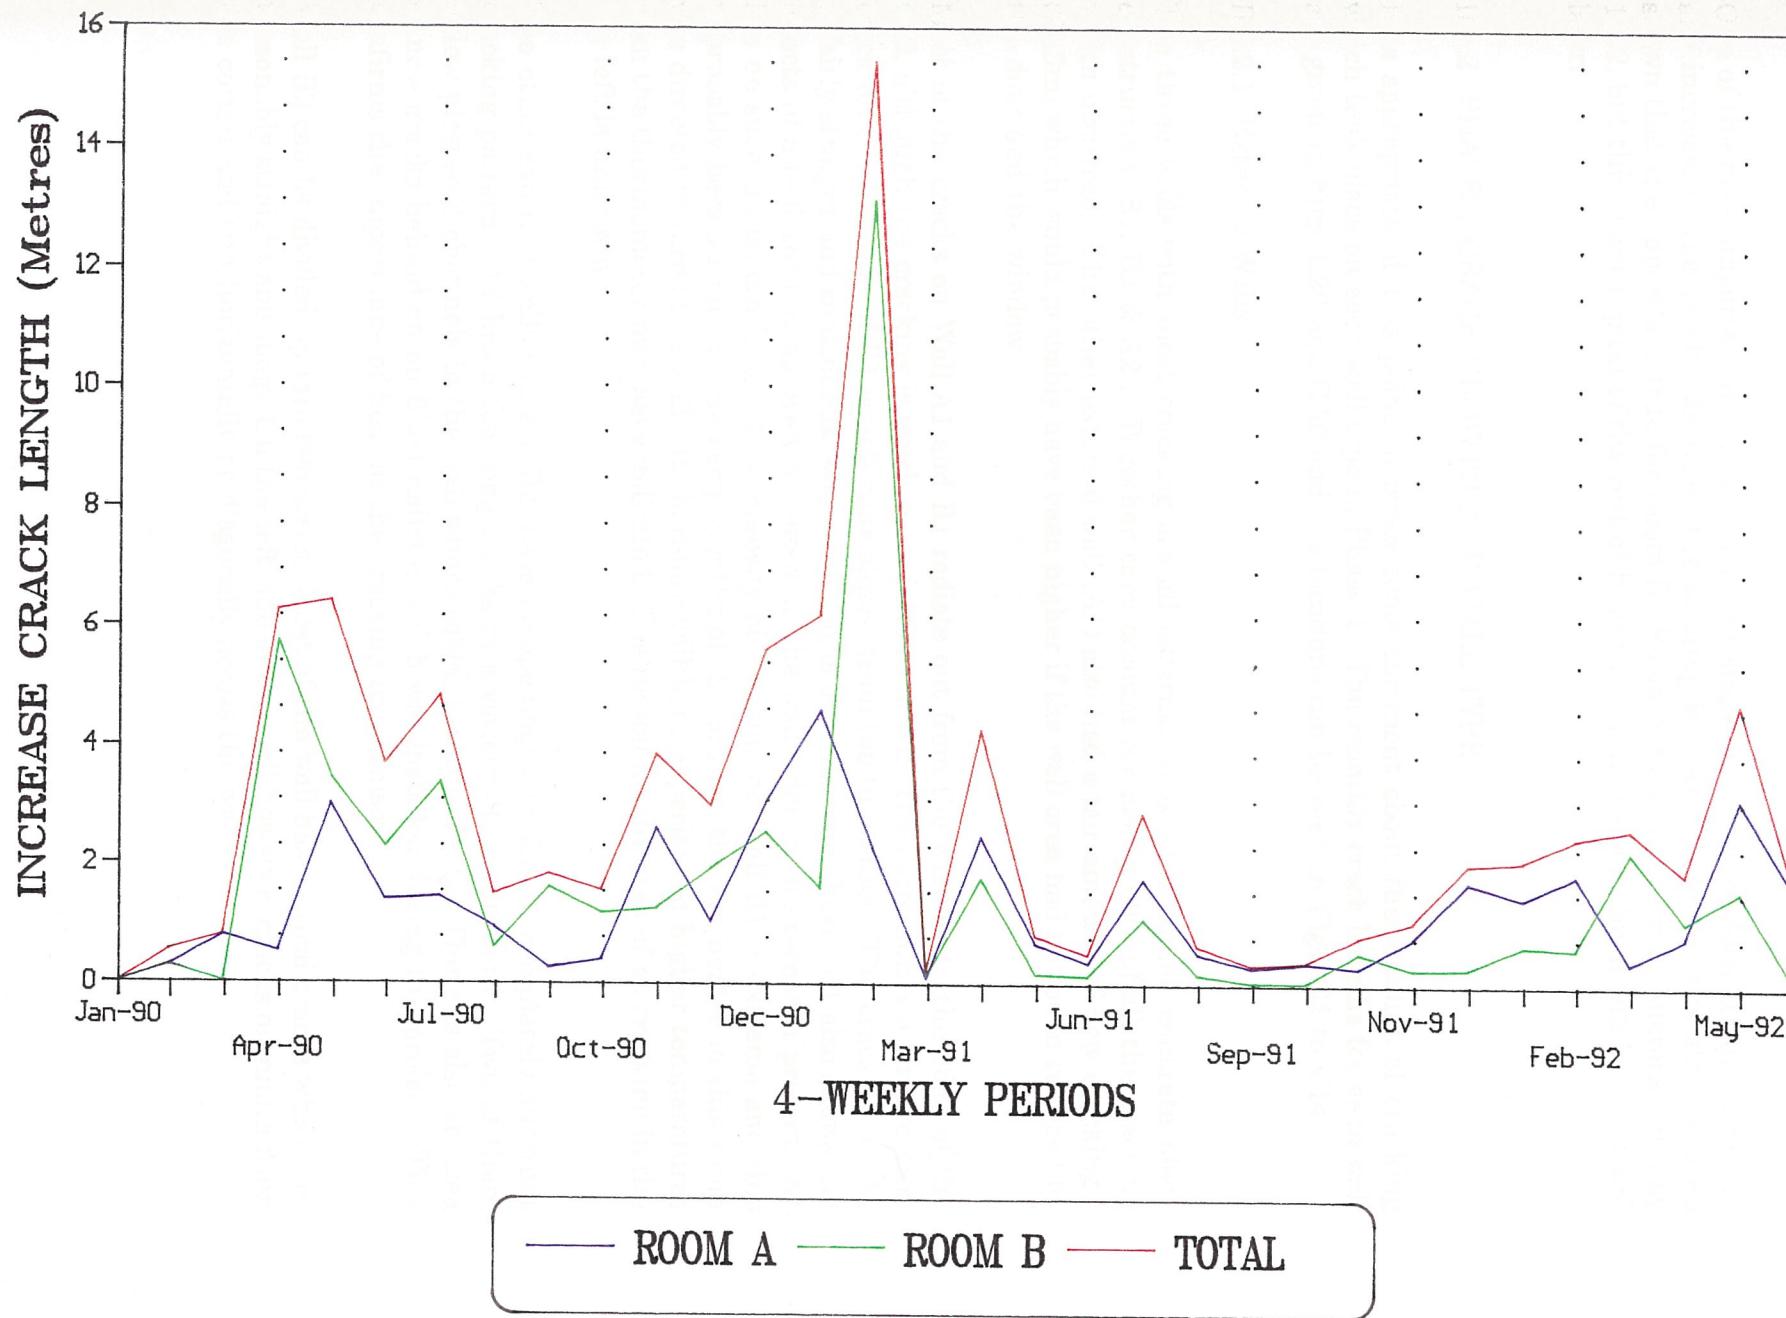
Fig. II.5.1

MONTHLY CRACK INCREASE

months where the crack increase exceeds 3m but the highest in Feb 1991 of 13.137m is over twice as much cracking as the next highest (5.739m) in Apr 1990.

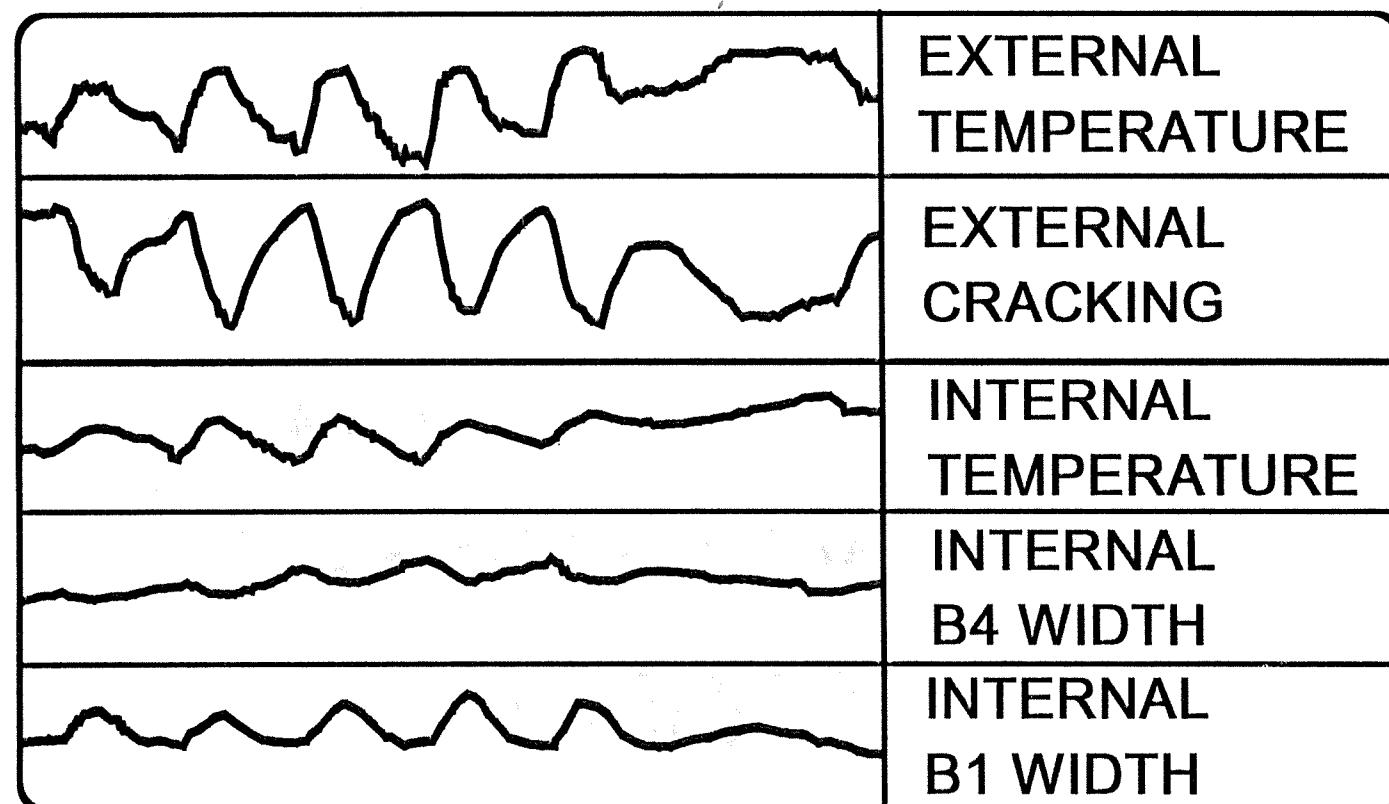
WEEKLY CRACK WIDTHS AND TEMPERATURES

- NO HEATING -

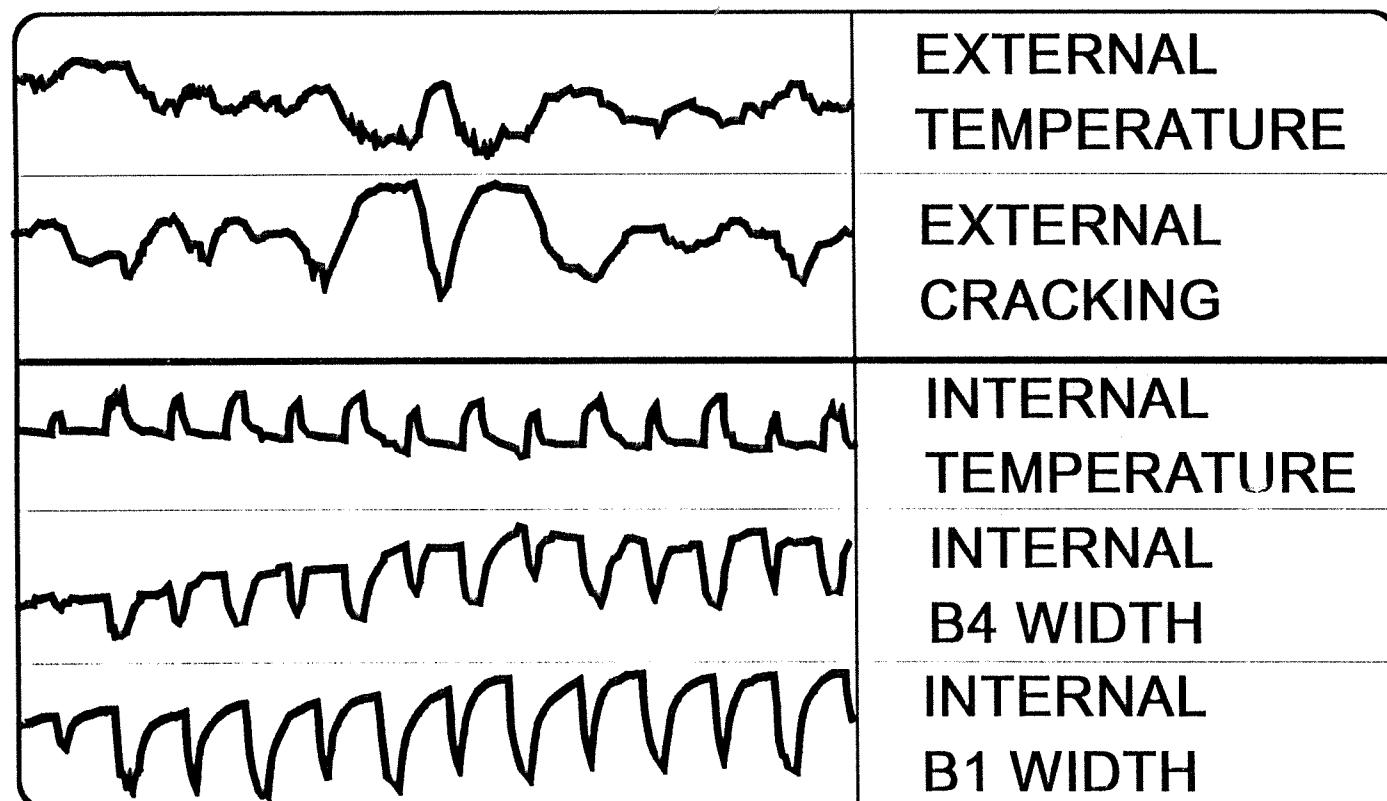
Fig. II.6.2

WEEKLY CRACK WIDTHS AND TEMPERATURES - HEATING ON TWICE DAILY -

a 0.1 decrement factor. Ventilation will affect this and in fact the internal air temperature follows the external temperature quite closely. However the plaster temperature will be some function of the internal and external temperatures and is likely to lag behind both of these. When there is no heating the B1 crack width therefore reflects the lag in plaster temperature. This apparent positive correlation between temperature and crack width arises because the lag is of the same order as the diurnal variation.

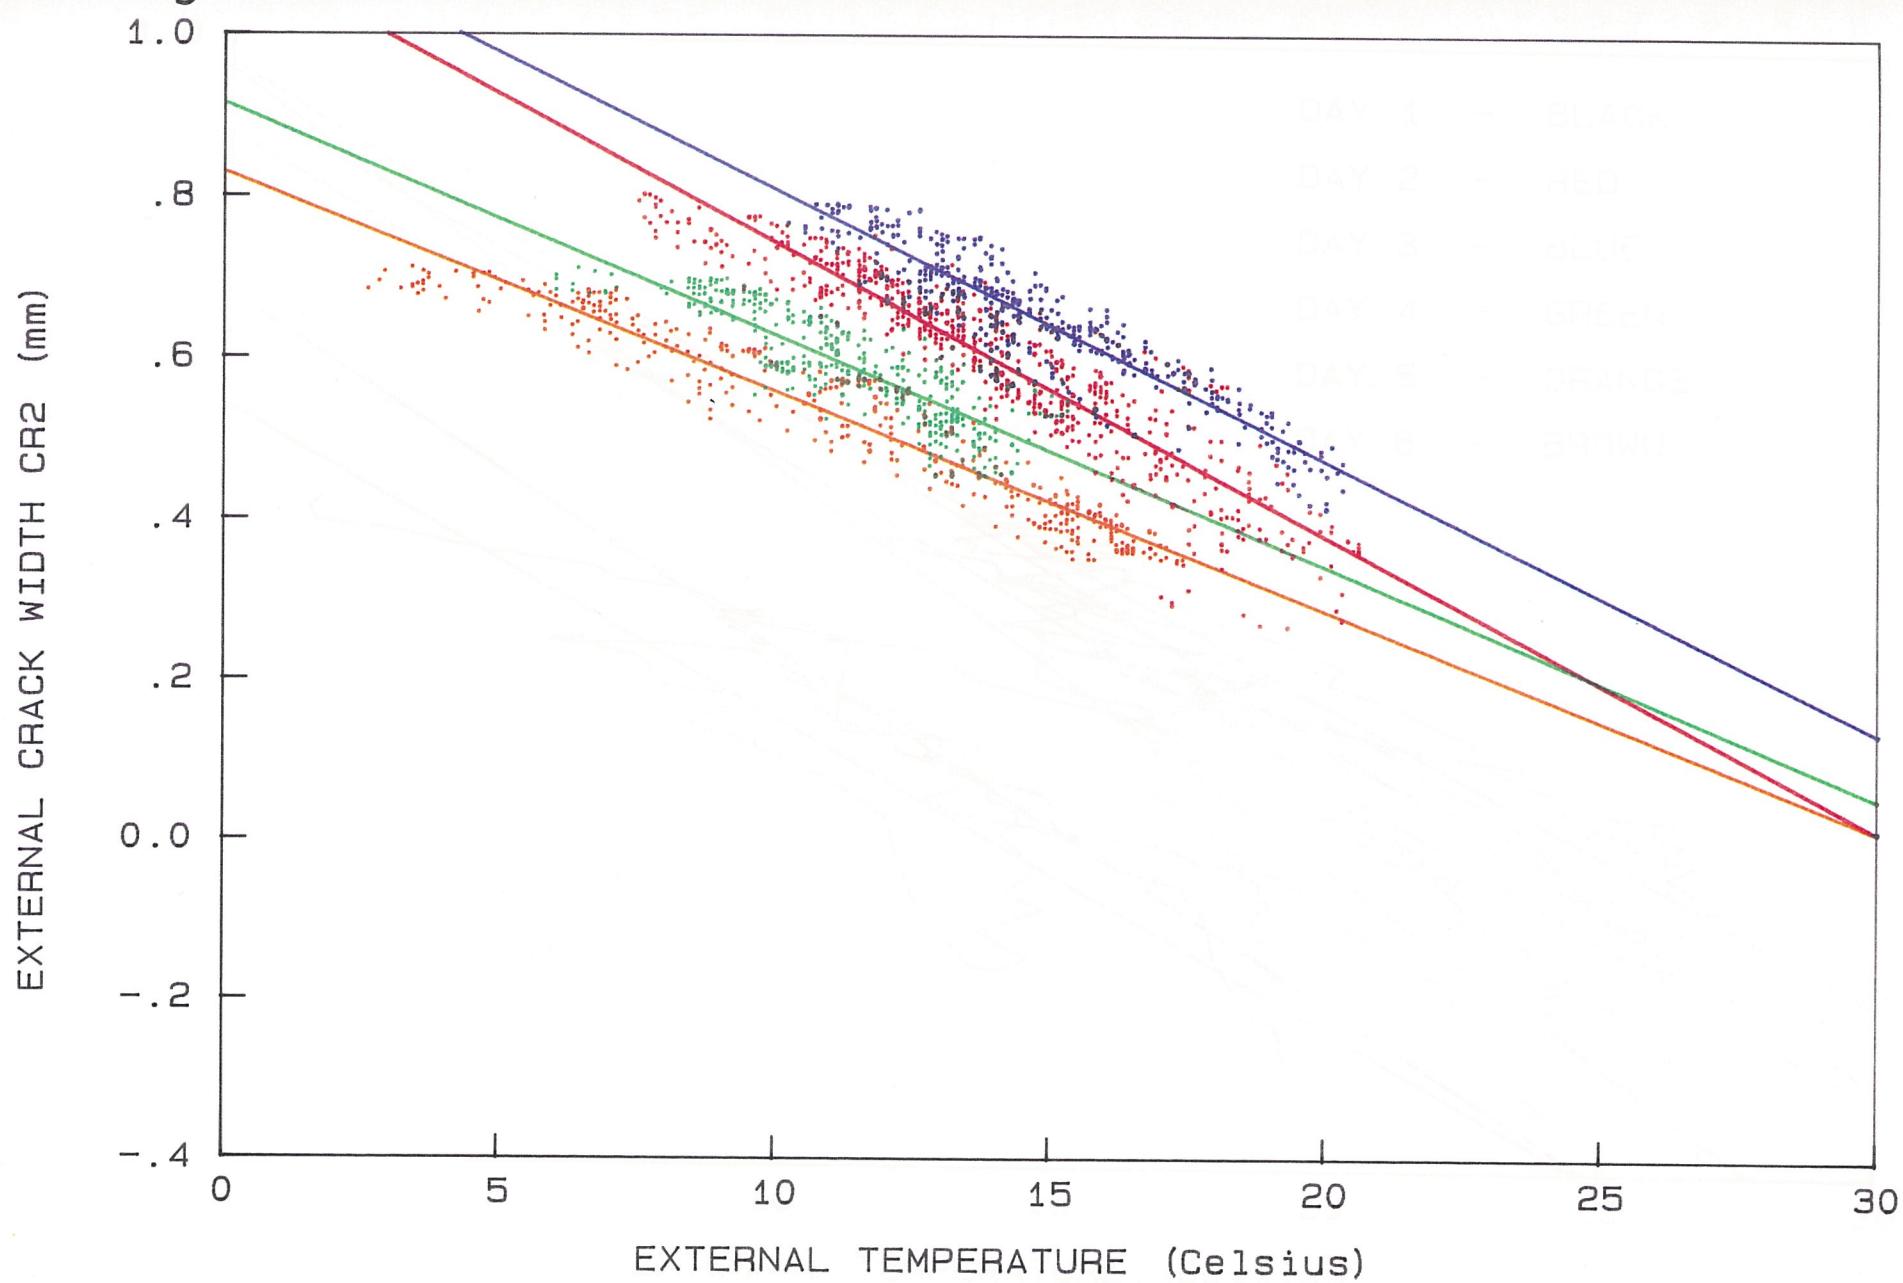
Fig. II.6.3

EXTERNAL DATA FOR 3/9/90 TO 30/9/90

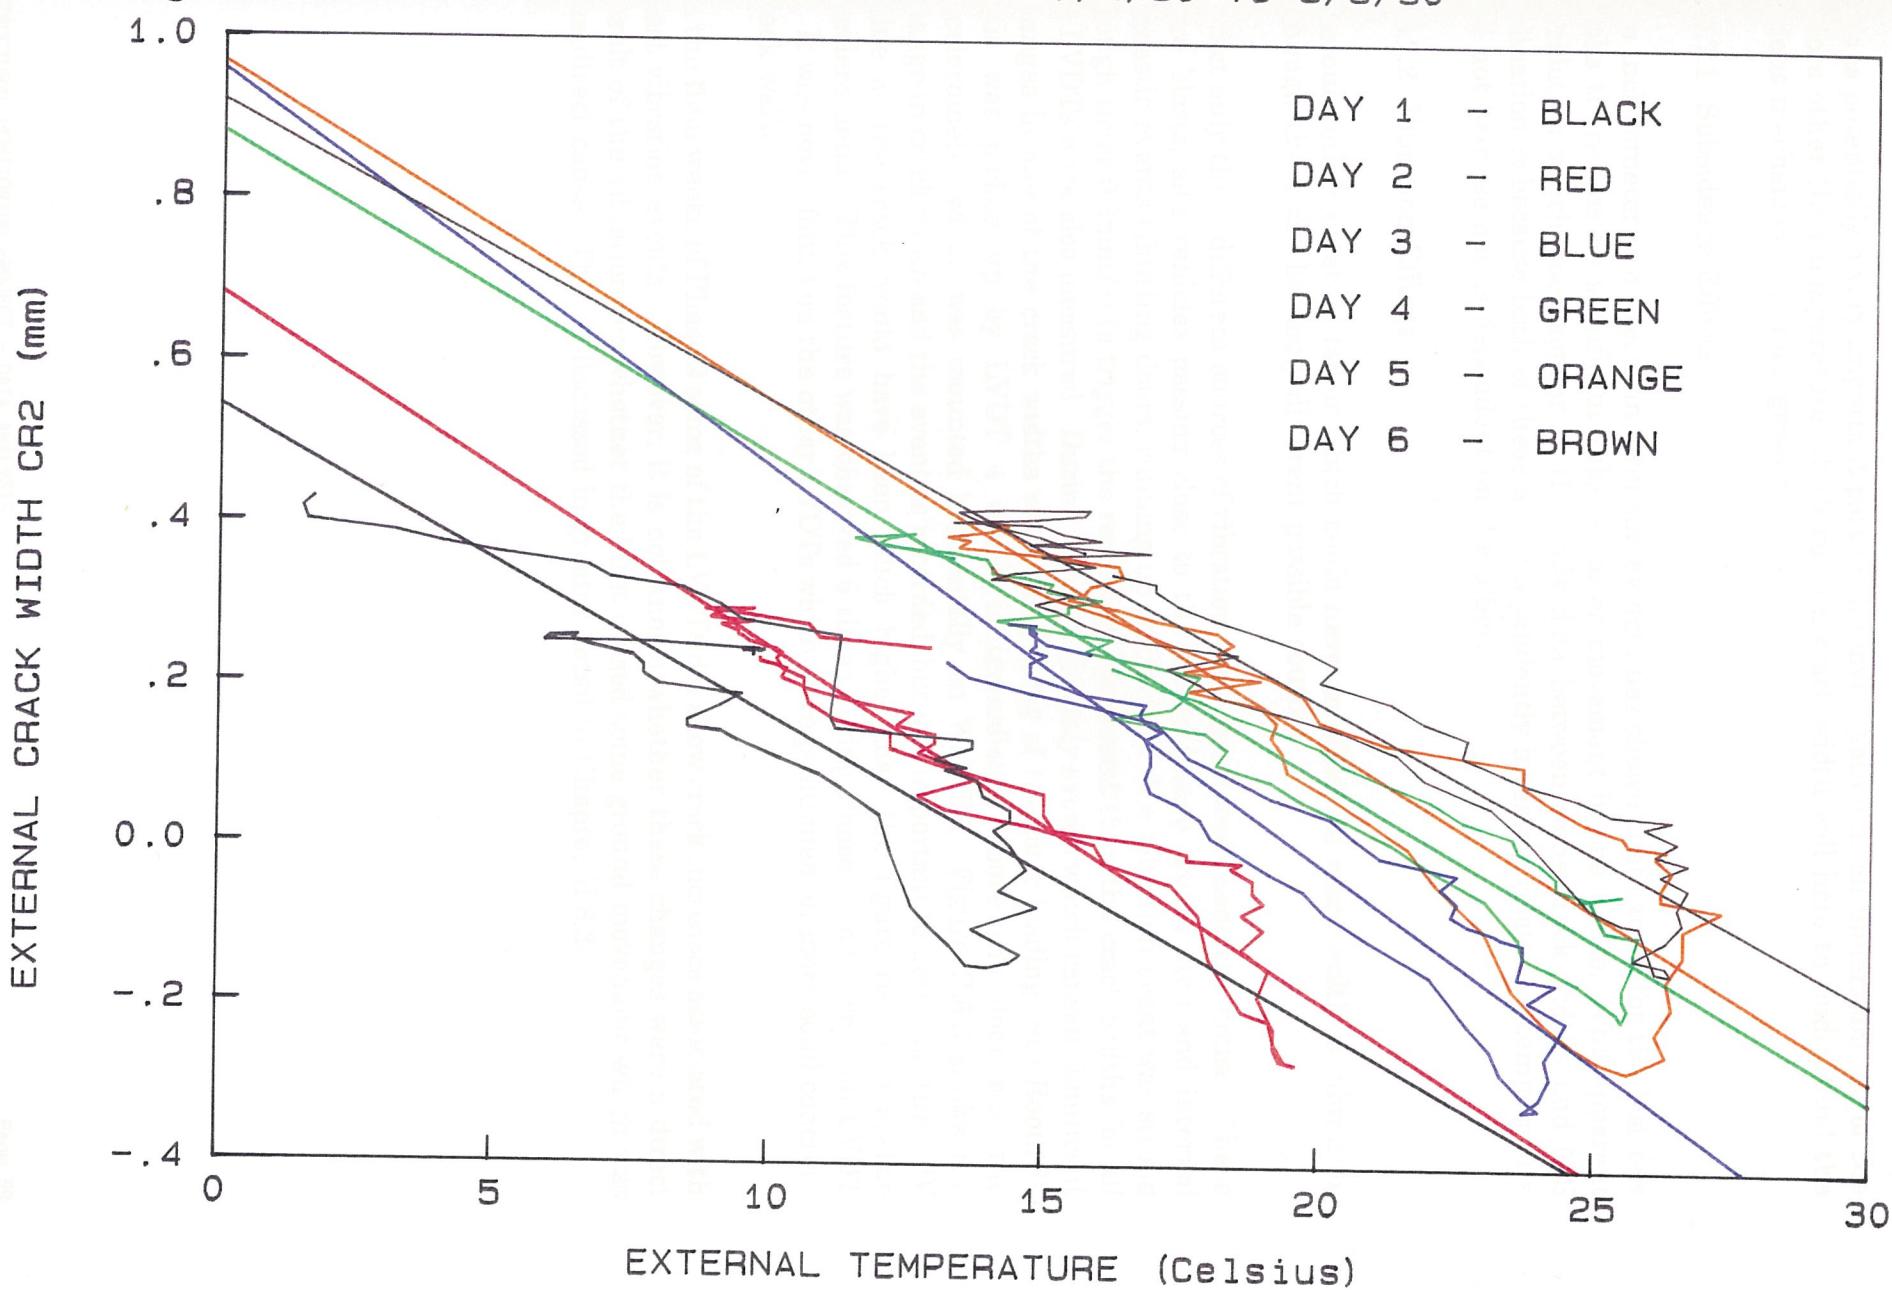
Fig. II.6.4

EXTERNAL DATA FOR 30/4/90 TO 5/5/90

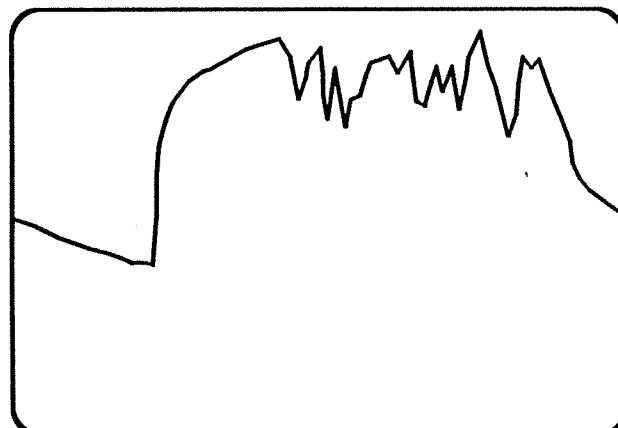
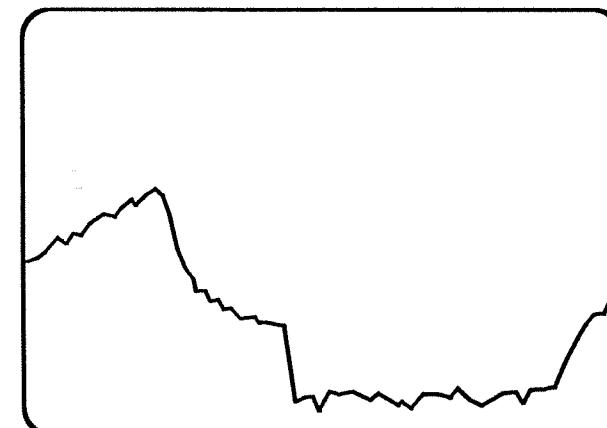
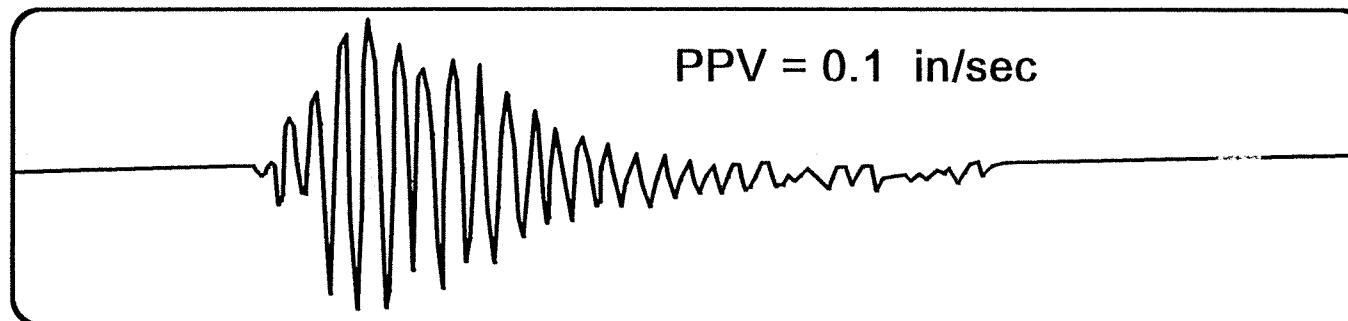
NON BLAST VIBRATION

ROOM TEMPERATURE

CRACK WIDTH

HORIZONTAL WALL VIBRATION FROM DOOR SLAM

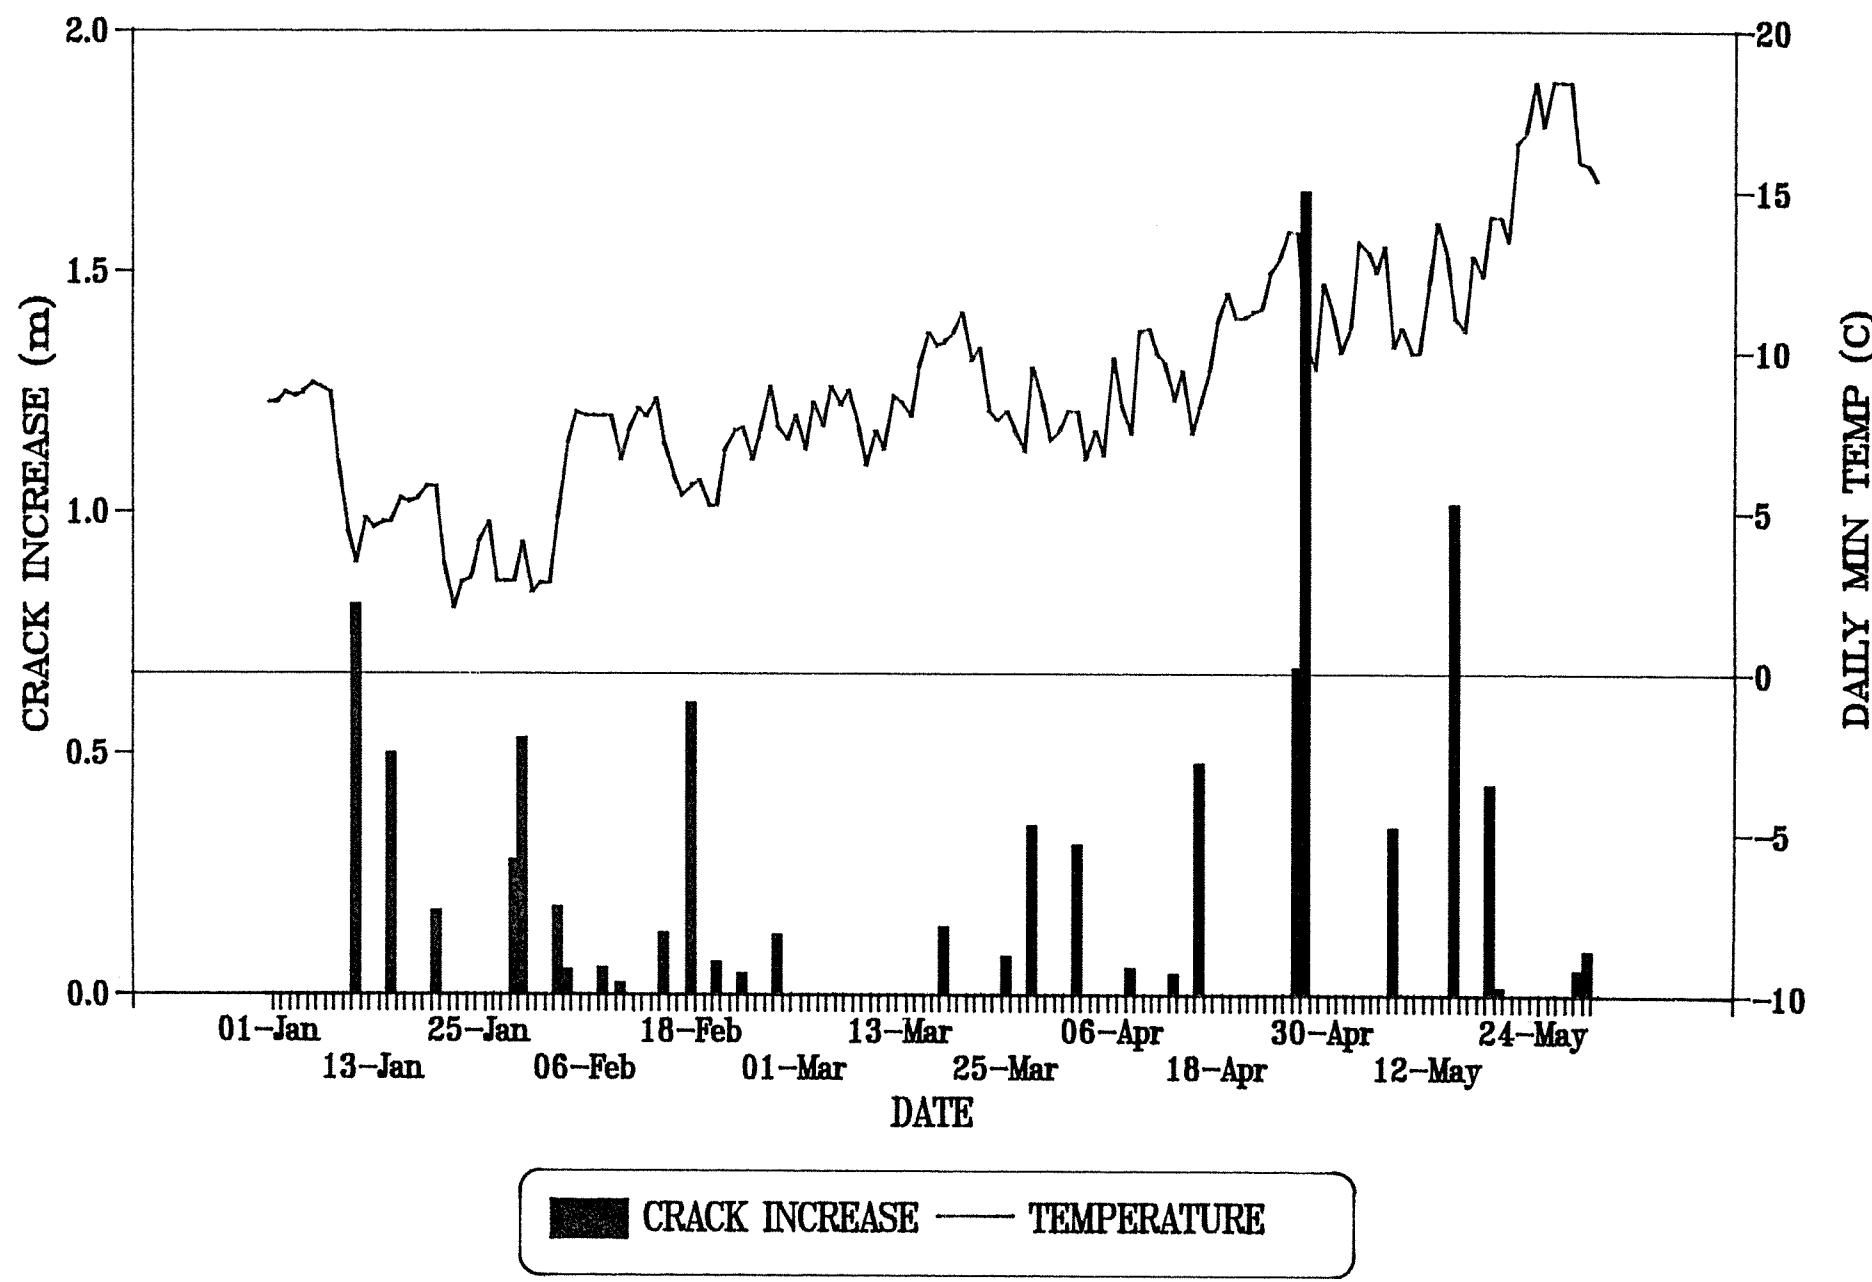
Fig. II.8.1

PHASE 2 CRACK ANALYSIS
ROOM A

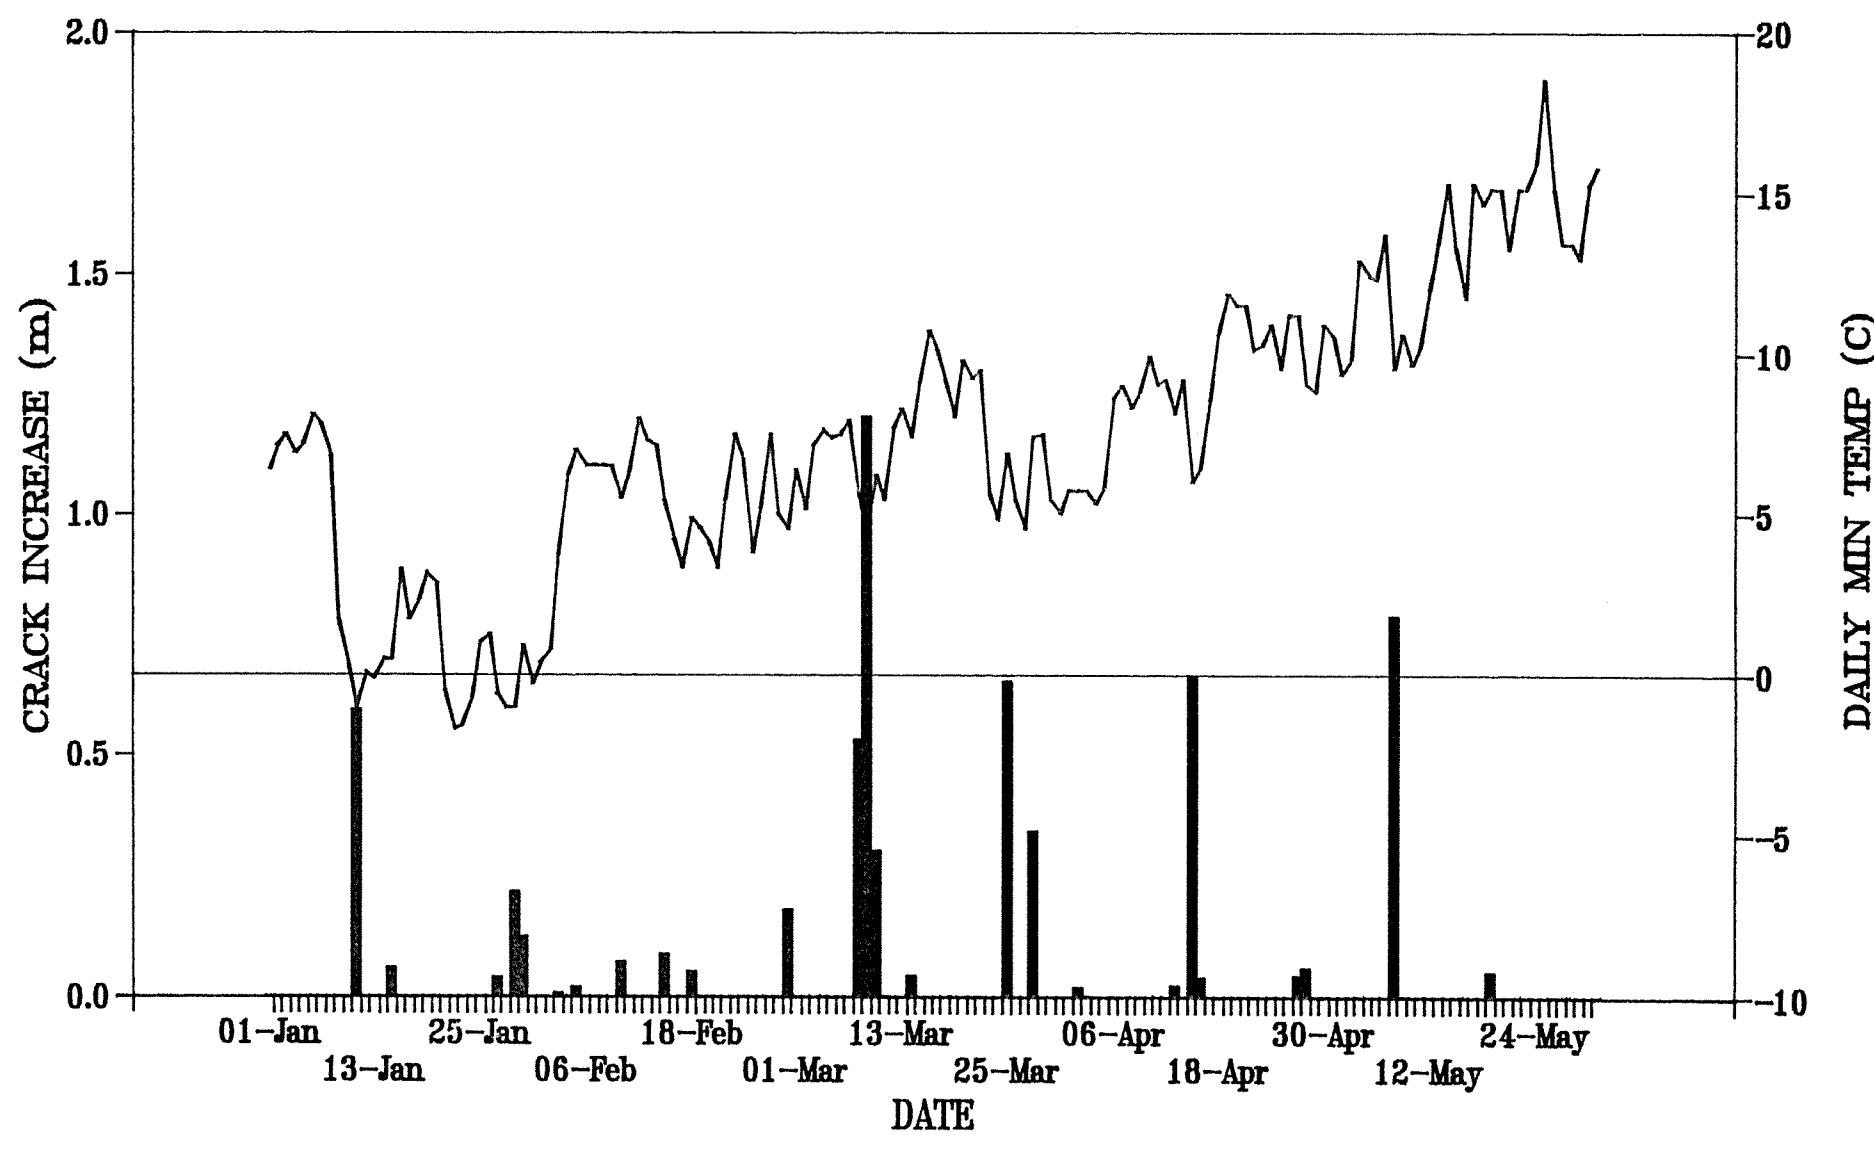
Fig. II.8.2

PHASE 2 CRACK ANALYSIS
ROOM B

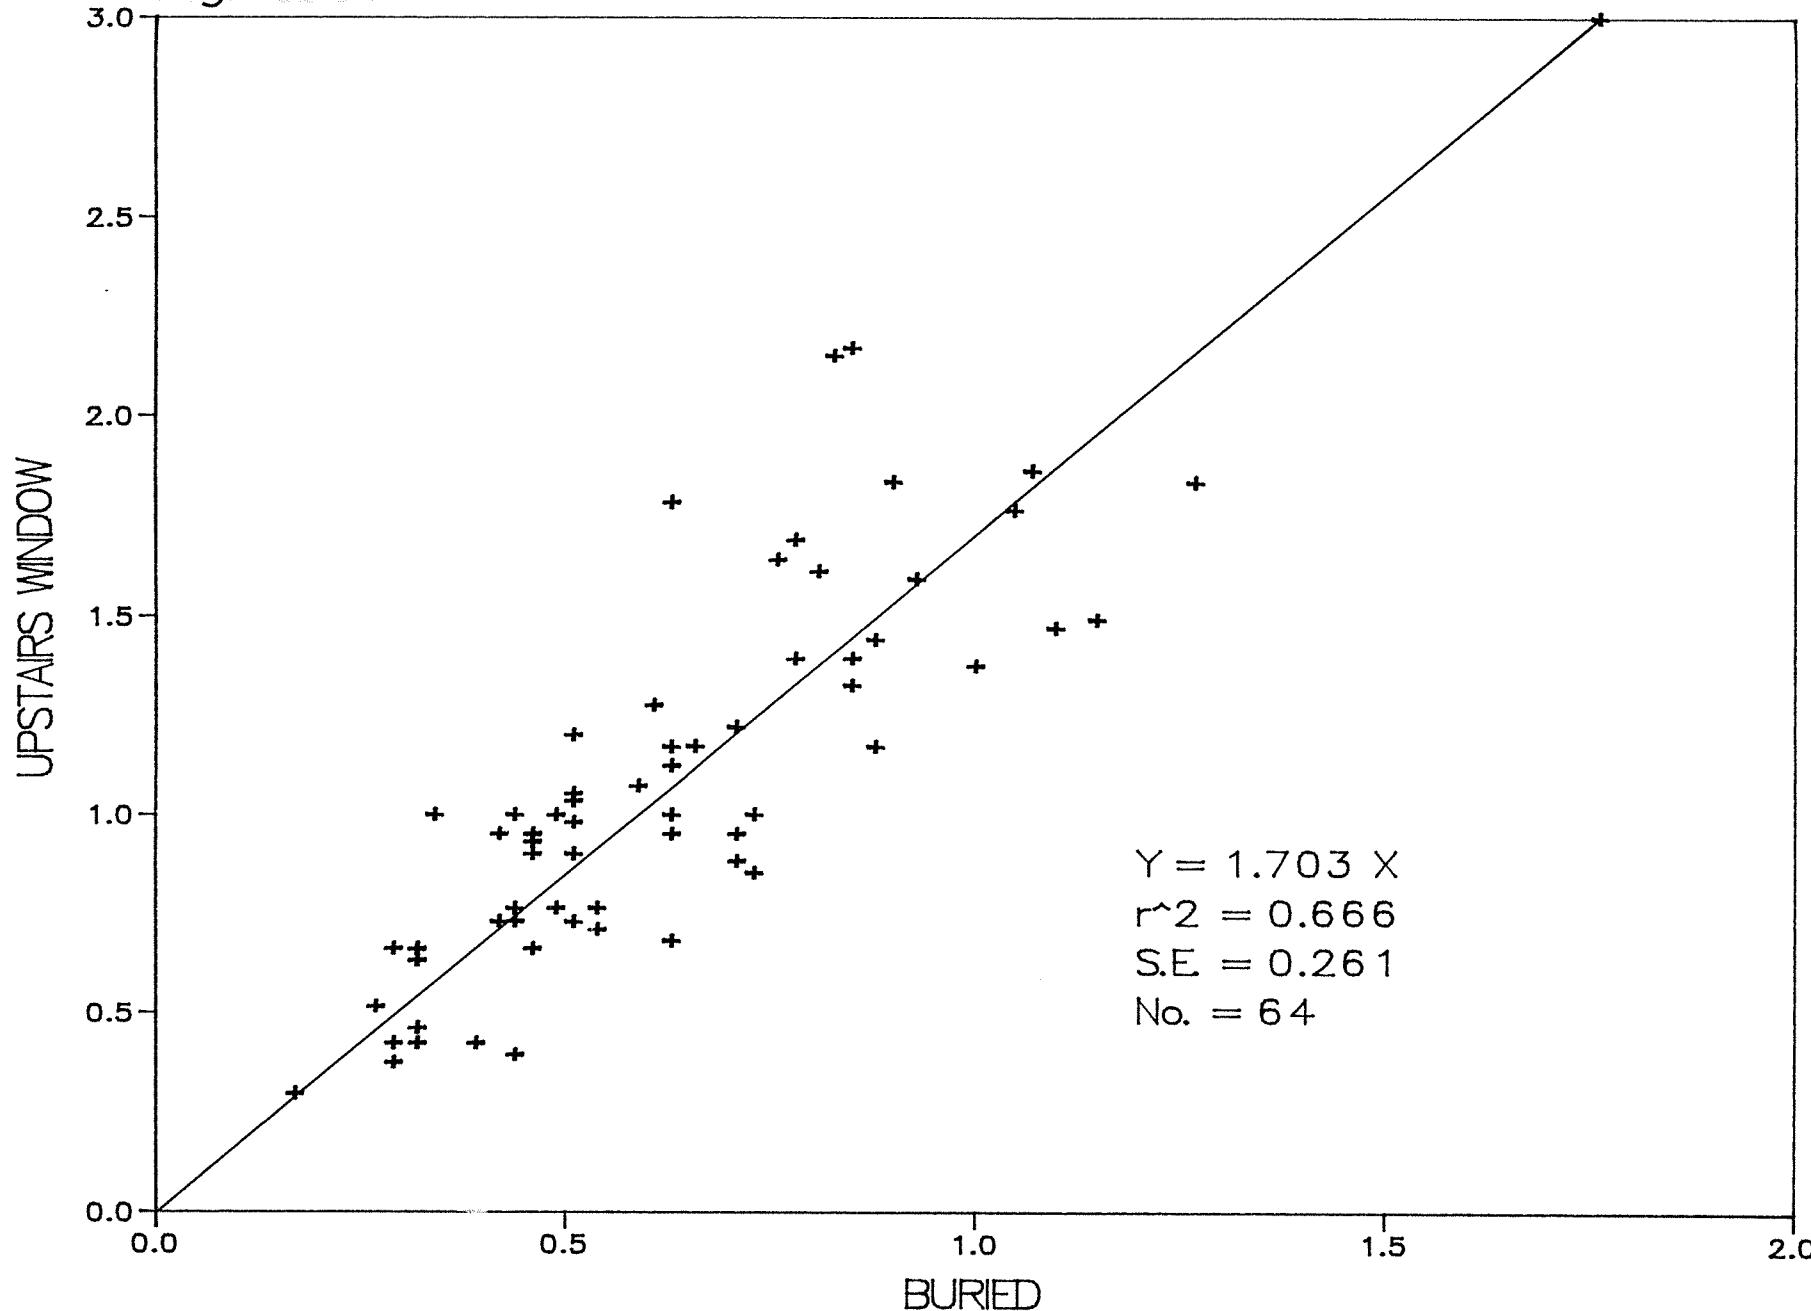
Fig. II.9.10

LONGITUDINAL

is not surprising as it is the longitudinal transducers which are monitoring the vibrations perpendicular to the wall and it is this direction which has the greatest freedom of movement. The other two directions (vertical and transverse) are both in the same plane as the wall and so are restrained and show only a slight amplification.

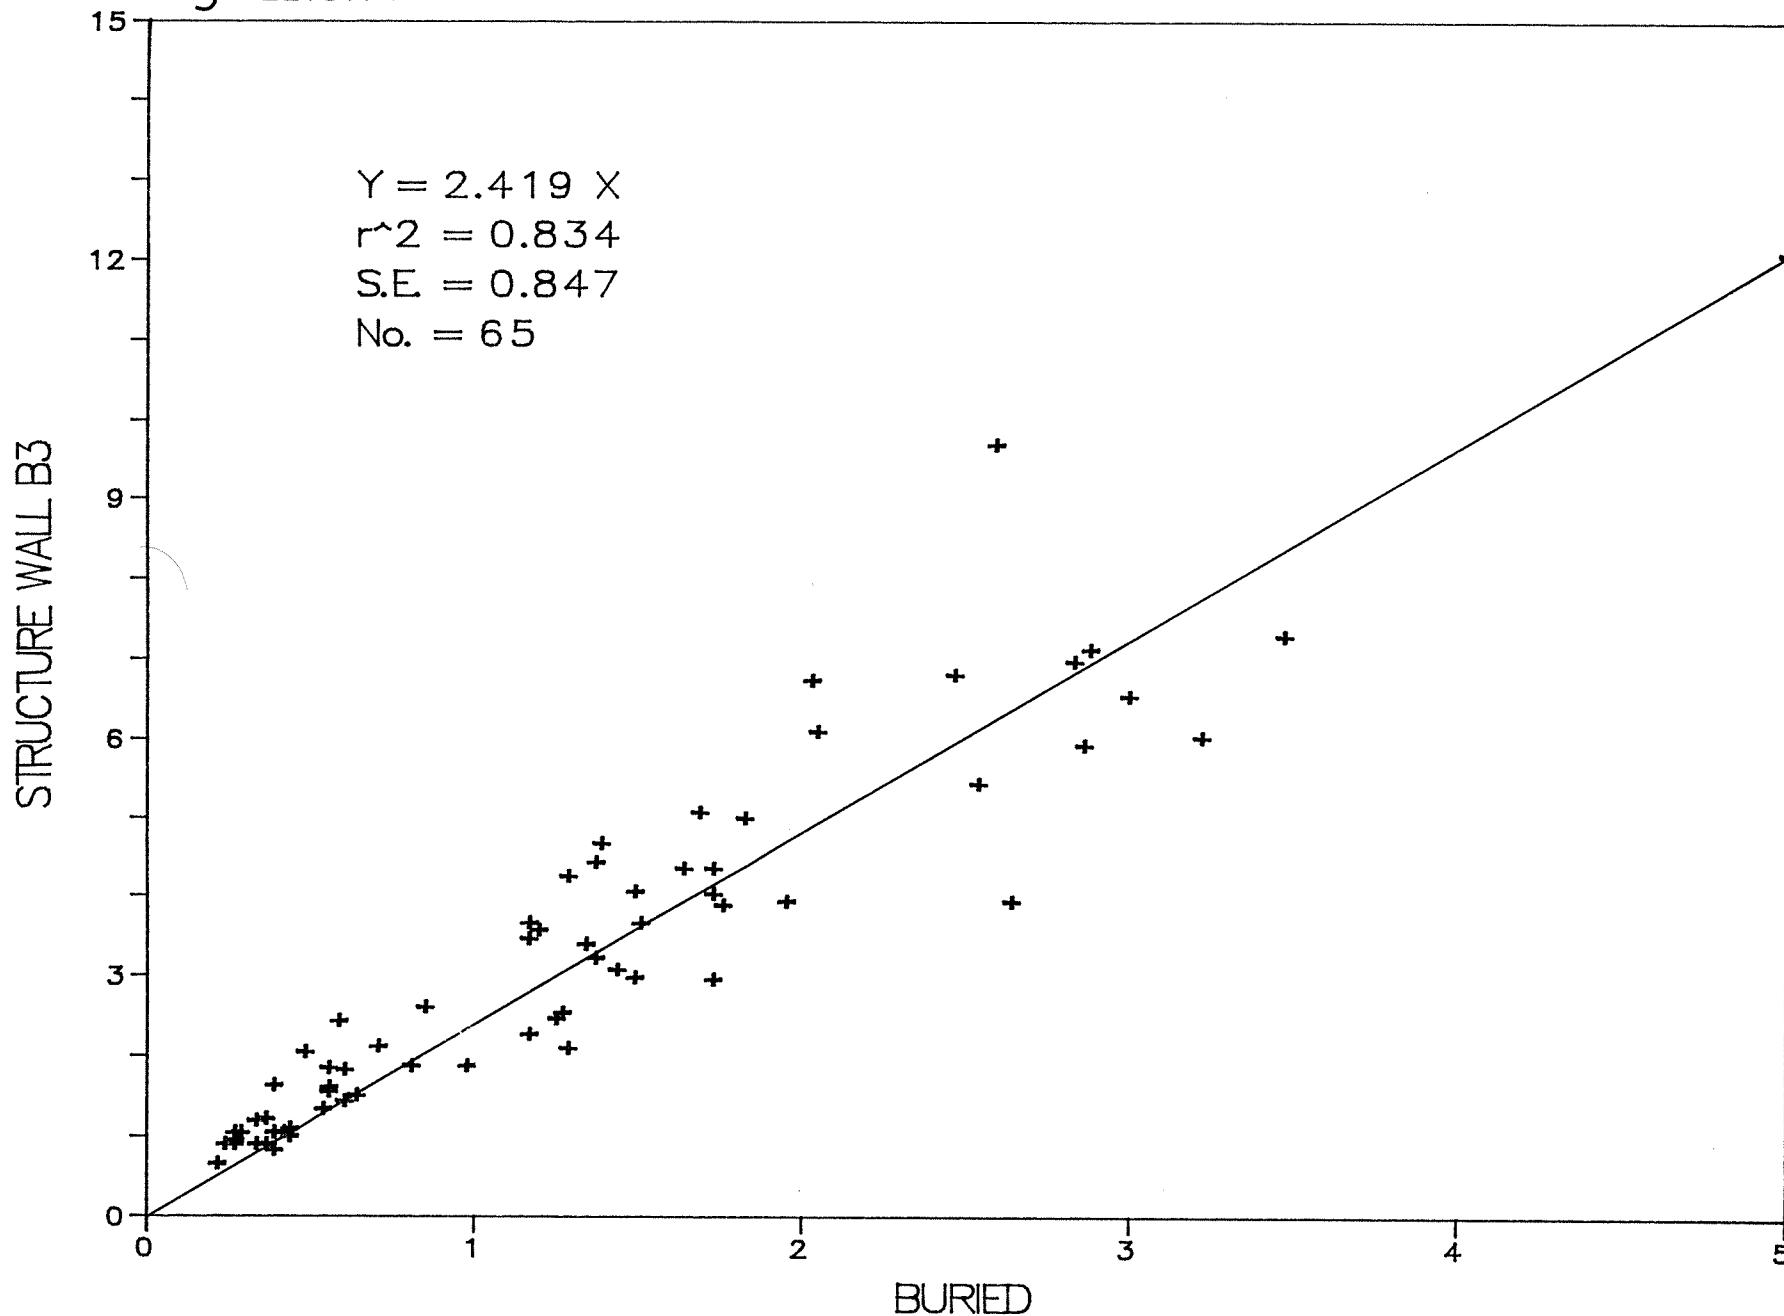
Fig. II.9.14

HORIZONTAL MOTION
