STRUCTURAL MONITORING PROJECT

A report to British Coal Opencast on the Effects of
Opencast Blasting Operations on Residential Structures

Blasting Research Group

September 1993

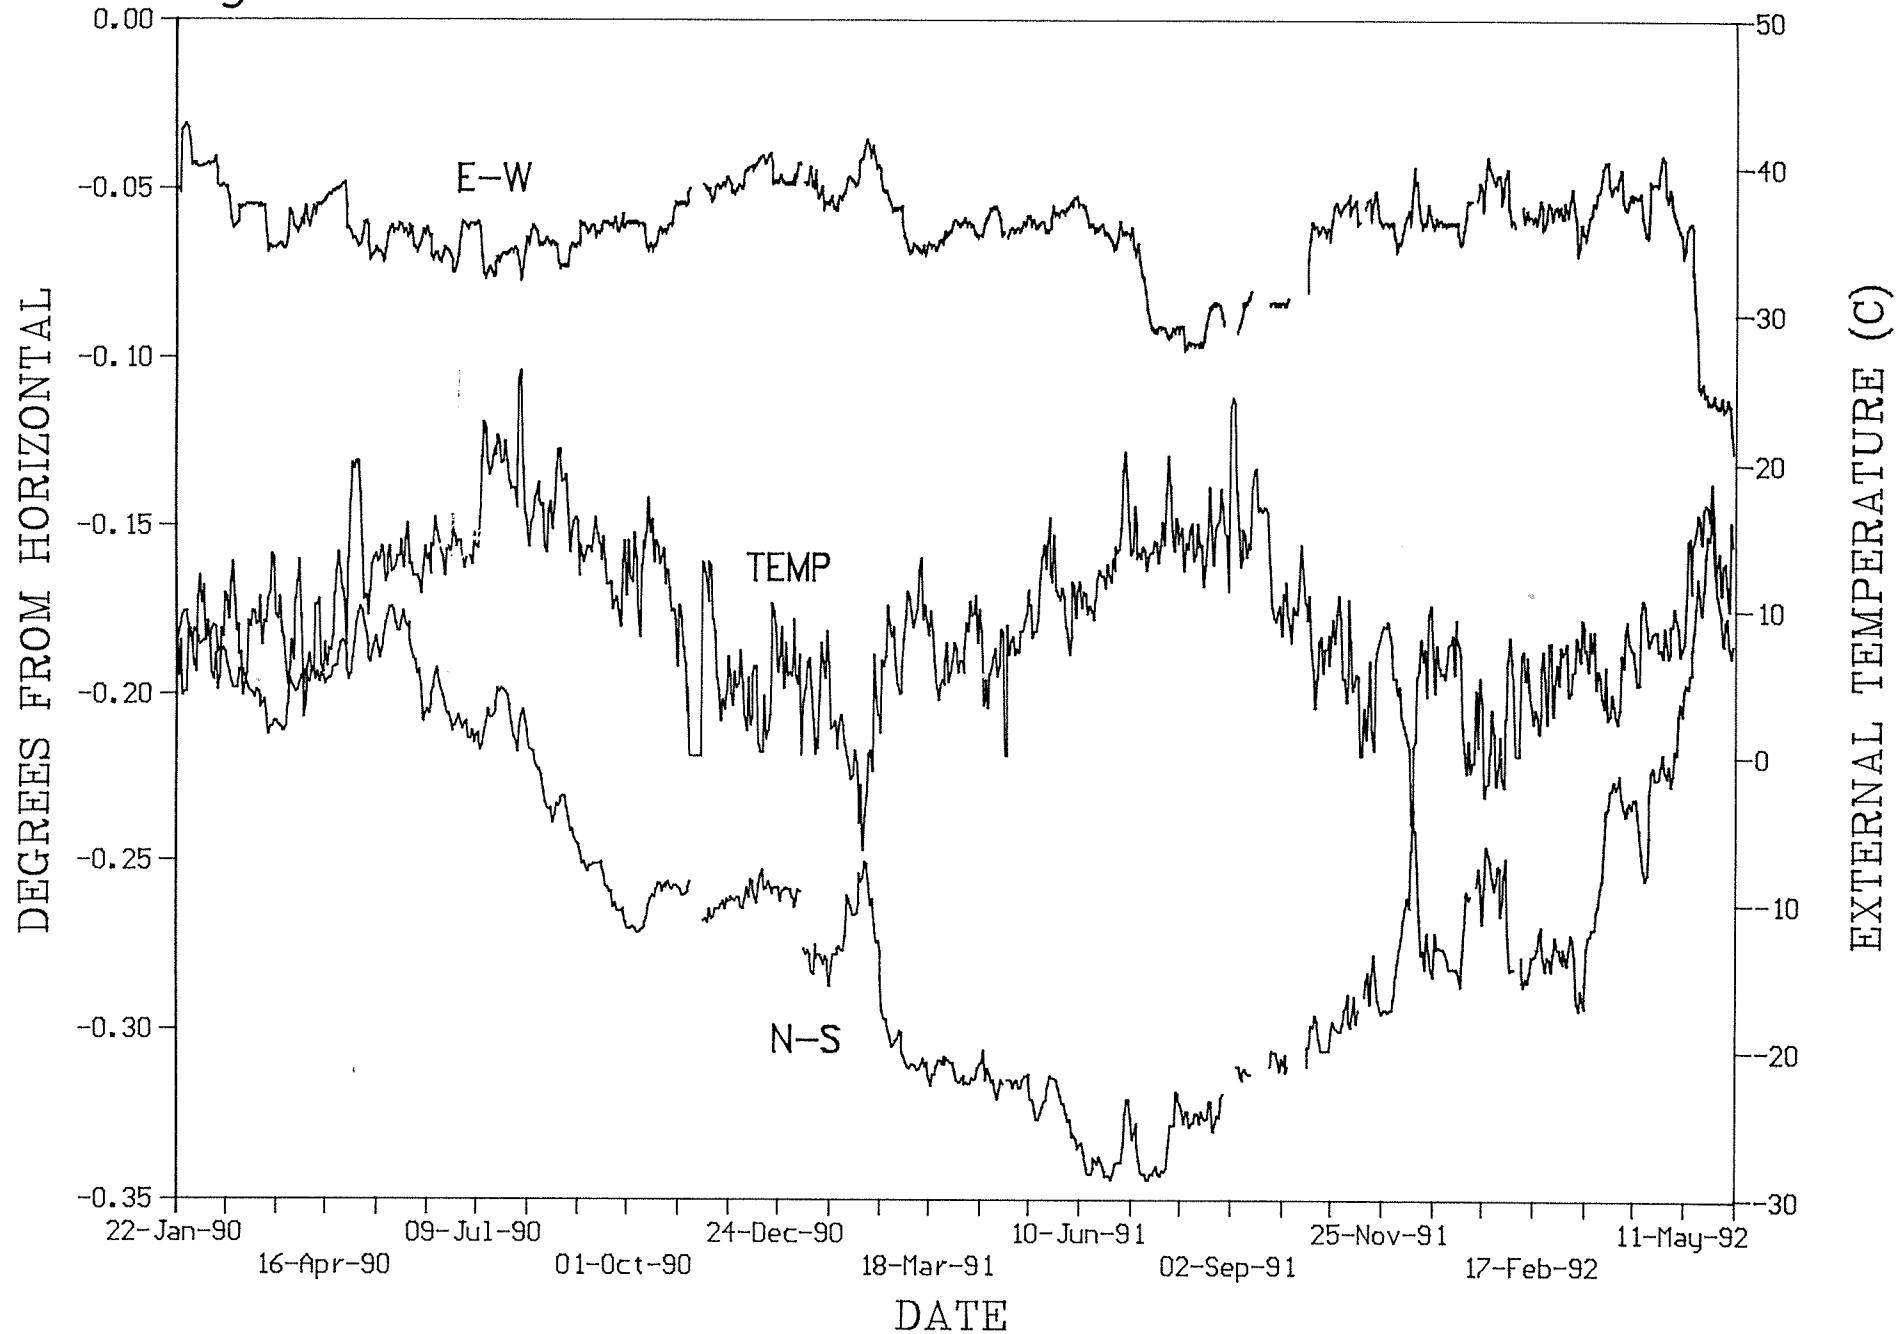
Fig. A.11

INCLINOMETERS & TEMPERATURE
